RESEARCH MEMORANDUM

PRELIMINARY INVESTIGATION OF SEVERAL ROOT DESIGNS FOR
CERMET TURBINE BLADES IN TURBOJET ENGINE

III - CURVED-ROOT DESIGN

NATIONAL ADVISORY COMMITTEE
FOR AERONAUTICS

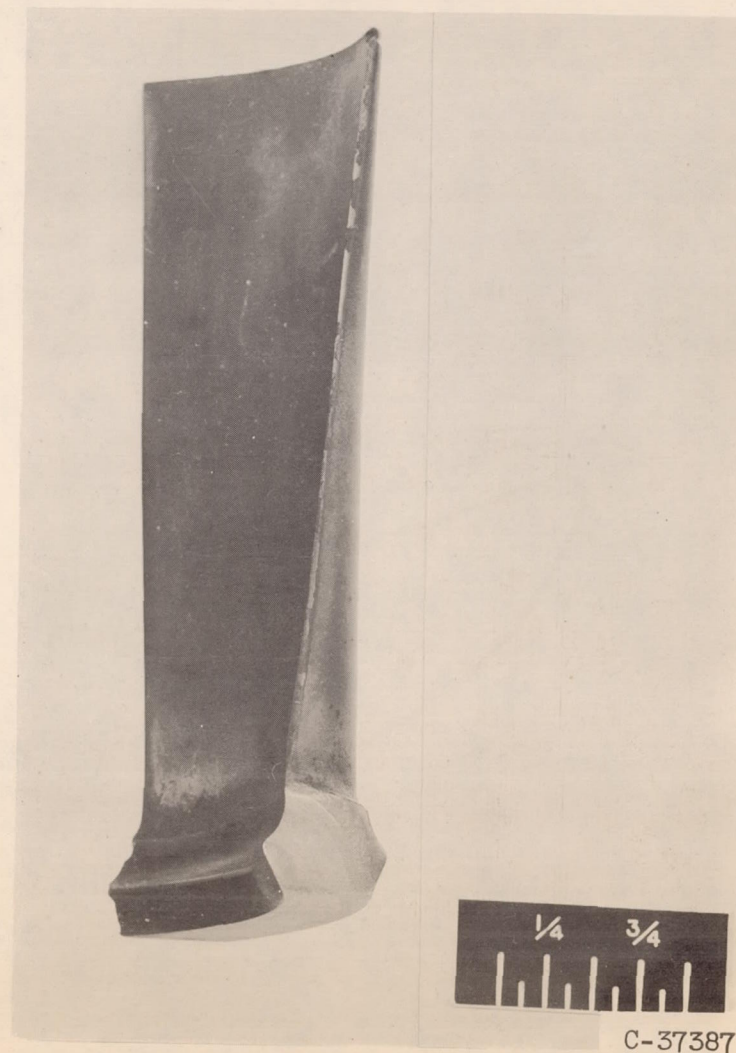
C-37387

Run 1. - The curved-root blades of run 1 successfully completed 150 hours. One of them is shown in figure 3. Except for a discoloration of the surface, no change in the blade during operation was detected. During the course of this run the engine was shut down 19 times.

Figure 3. - Cermet turbine blade after 150 hours of operation. Run 1.

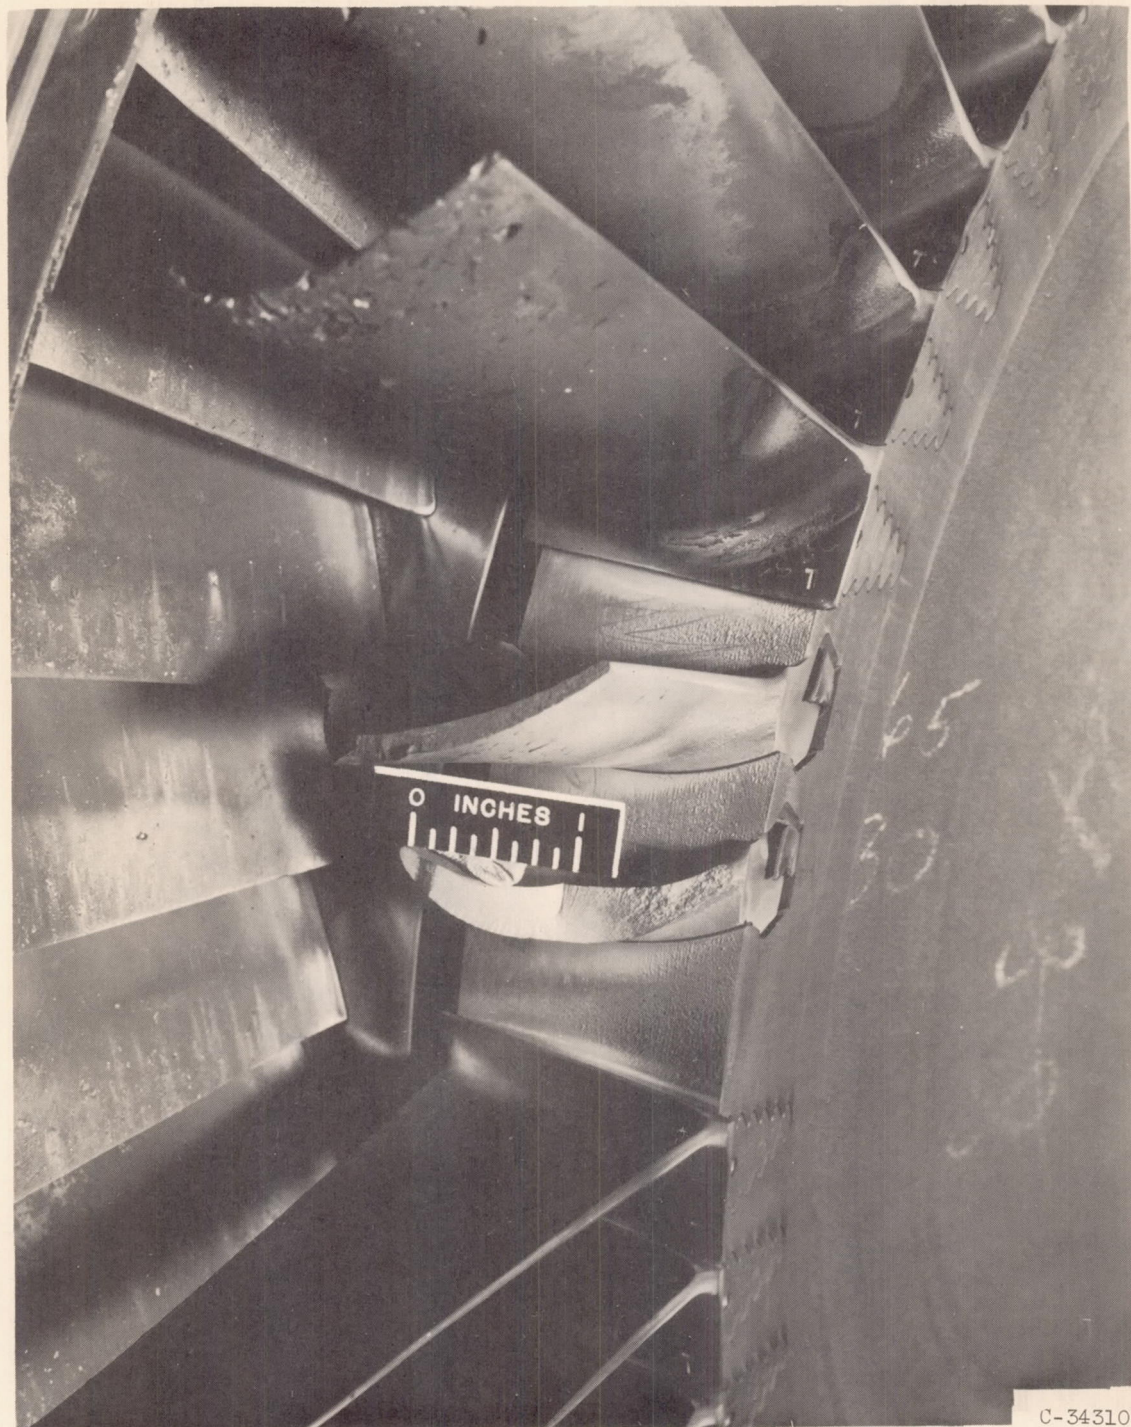
(a) Originally failed blades.

Run 2. - The second set of curved-root blades had accumulated 77 hours and 4 minutes at rated speed when an airfoil failed, as shown in figure 4(a), and damaged the other cermet blades (fig. 4(b)). While no definite cause for the failure was established, the blades were severely corroded along the leading edge. The enlarged view of the leading edge of the failed blade (fig. 5) is typical of the appearance of the leading edges of all the cermet blades in this run. X-ray diffraction of flakes chipped from the edges of the blades did not indicate the presence of foreign material; only the constituents or their oxides were detected. Since this corrosion was not evident in the many previous engine runs with this composition, it is not considered characteristic of either the nominal composition or the normal operating environment.

Figure 4. - Failure of curved-root cermet turbine blades after 77 hours and 44 minutes at rated speed. Run 2.

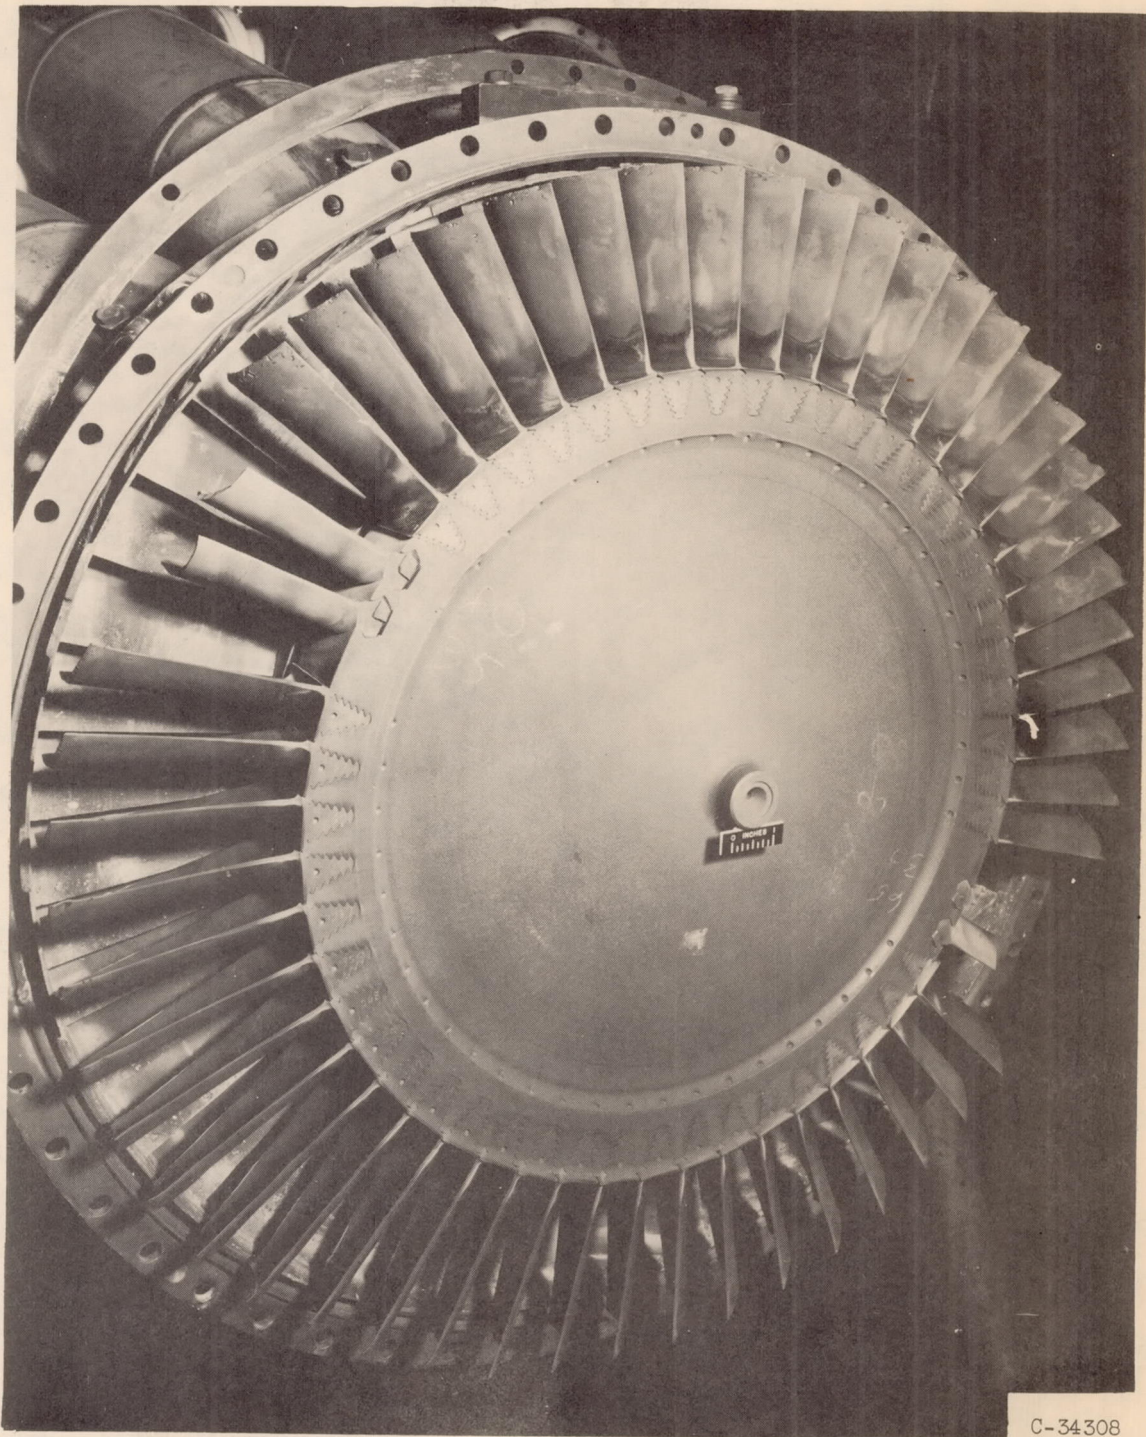
(b) Damage to entire wheel.

Figure 4. - Concluded. Failure of curved-root cermet turbine blades after 77 hours and 44 minutes at rated speed. Run 2.

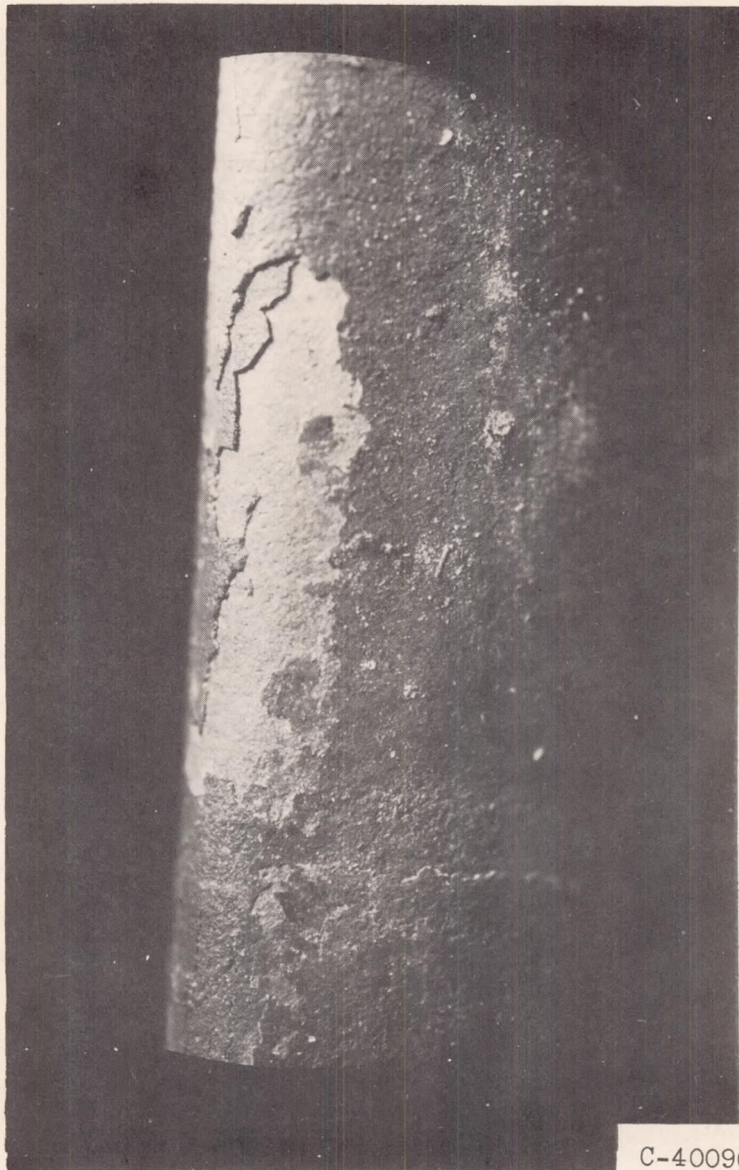
C-40090

Figure 5. - Enlarged view (X15) of failed curved-root cermet turbine blade showing corrosion along leading edge. Run 2.

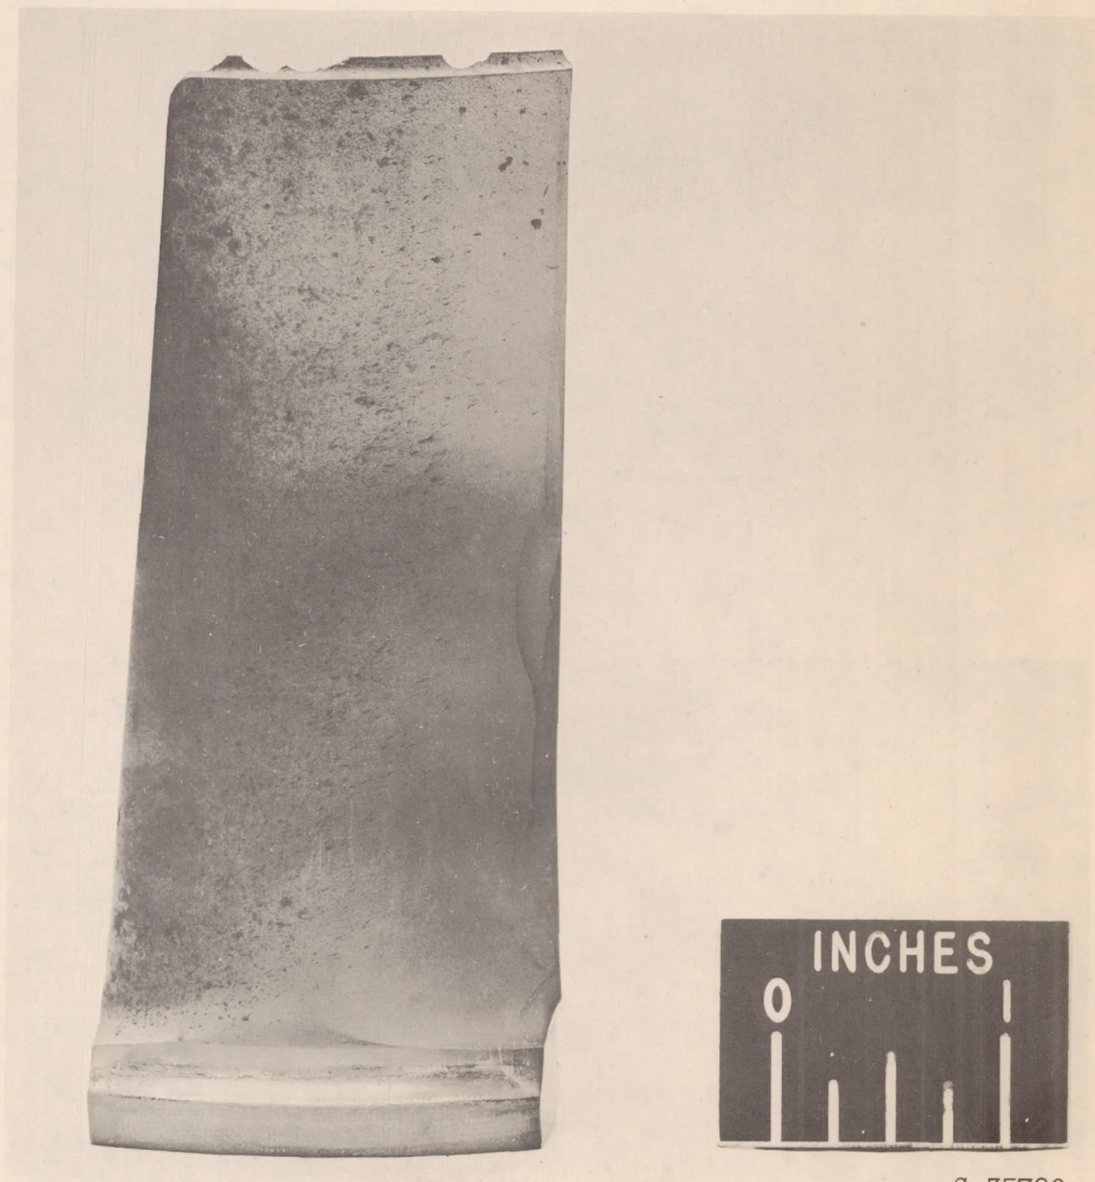
C-35790

Run 3. - In run 3, a curved-root blade failed at the base of the airfoil after 132 hours and 15 minutes at rated speed. A black powdery substance spotted the suction surfaces of all blades, particularly near the leading edges (fig. 6). X-ray diffraction patterns of scrapings of this powder indicated only carbon. Since the formation of carbon is unusual in this engine, the deposit indicates that the engine was malfunctioning. The deposit itself was tightly adherent; it was not removed when the blade was held against a linen buffing wheel. The tight adherence of the deposit as well as the presence of carbon near the origin of the fracture (fig. 7(a)) suggests that a chemical reaction may have occurred between the carbon and the blade material. Malfunction of the engine may have propagated the stress raiser formed by such a reaction. To investigate this possibility, carbon was collected from deposits in the combustion chambers of several engines and compacted into pellets. These were heated to 1500° F in a furnace, in contact with the surface of an unfailed curved-root blade. The carbon soon burned away, but the blade was left in the furnace to react with whatever ash or residue may have resulted. No reaction was detected after 200 hours at 1500° F. Although the fracture is located in an area of low vibratory stress, appearance of the fracture (fig. 7(b)) suggests a fatigue mechanism.

Figure 6. - Carbon deposits on curved-root cermet turbine blade after 132 hours and 15 minutes at rated speed. Run 3.

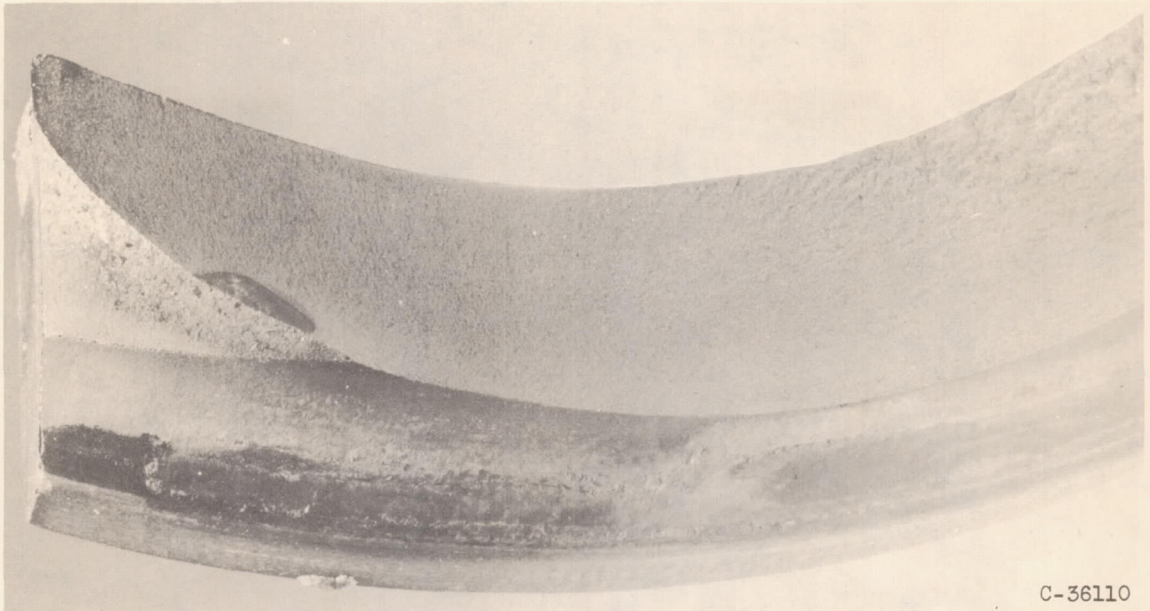
C-36110

(a) Failure location; base of airfoil.

Figure 7. - Failure of curved-root cermet turbine blade after 132 hours and 15 minutes at rated speed. Run 3.

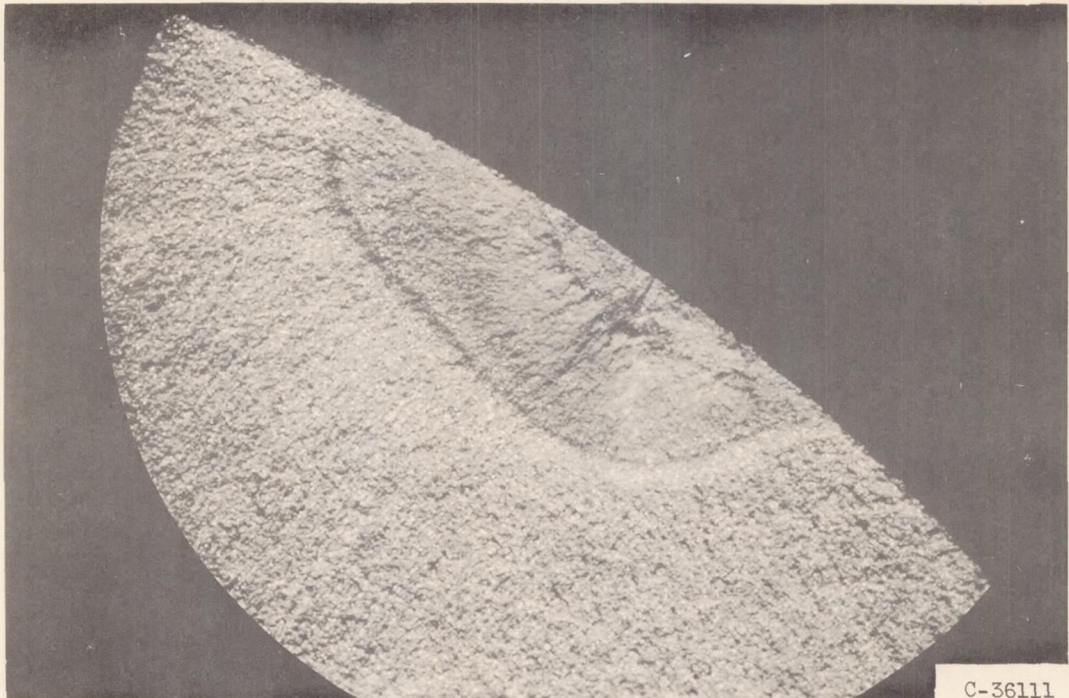
C-36111

(b) Origin of failure. X15.

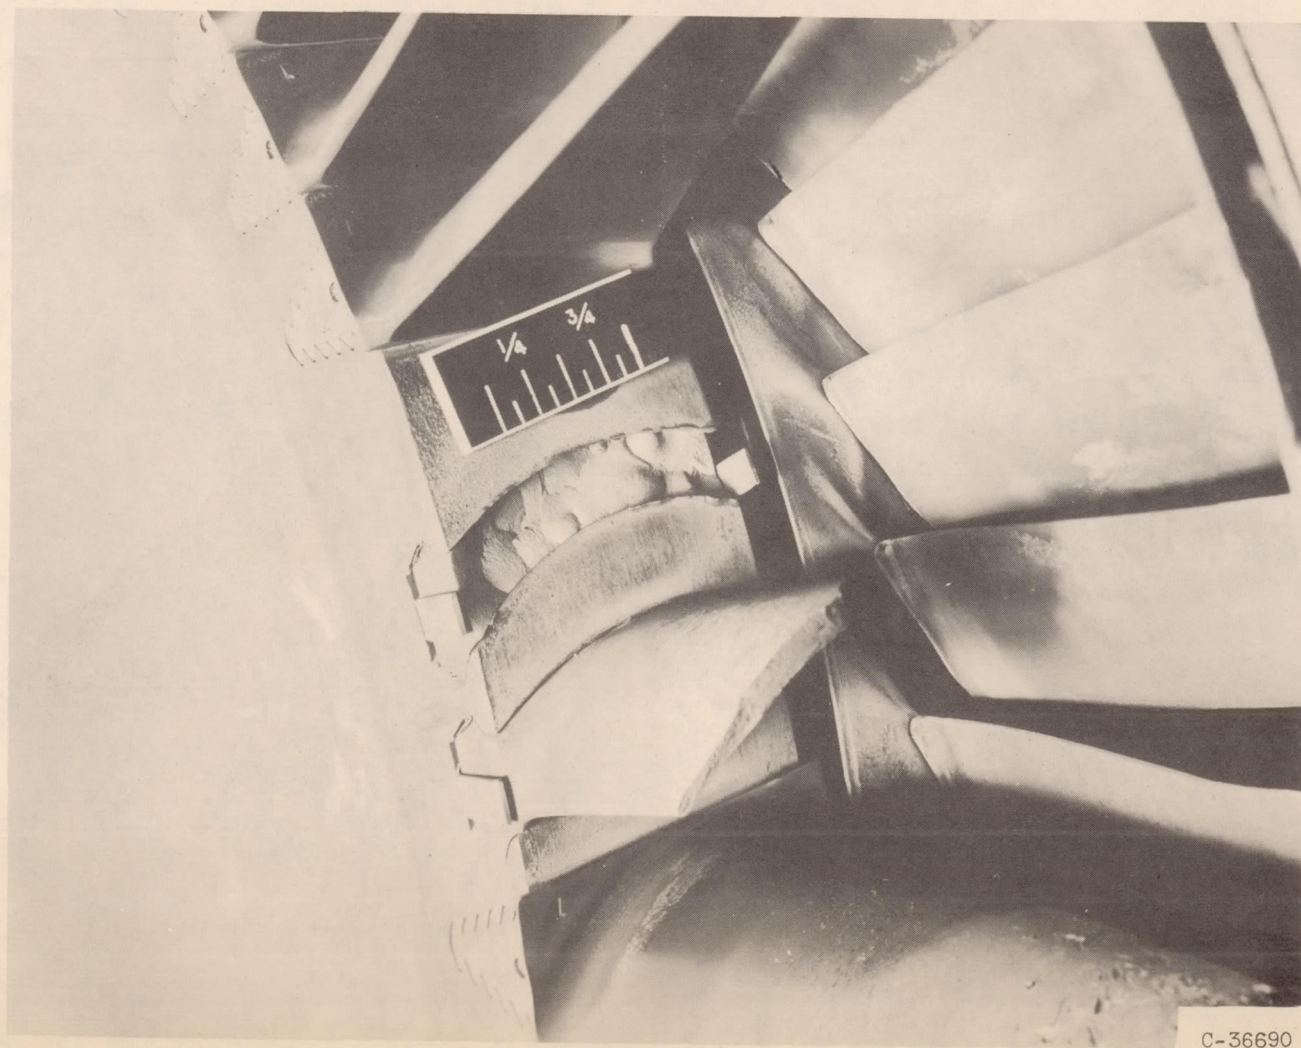
C-36690

Run 4. - A curved-root blade (fig. 8(a)) failed in the root after 142 hours and 58 minutes at rated speed, damaging the adjacent cermet blade but inflicting only minor damage to the opposing pair of blades (fig. 8(b)). The failure has the spalled appearance that has previously been attributed (ref. 4) to the presence of high compressive stresses,

particularly those resulting from the progressive pinching action of the turbine wheel during engine operation that involves many engine stoppages. During run 4, the engine was stopped and started 25 times. Reference 4 states also that the root radius used in this study is superior to the larger radii used previously from consideration of the build-up of these compressive stresses.

(a) Root failure showing spalled appearance characteristic of compressive stressing.

Figure 8. - Failure of curved-root cermet blades after 142 hours and 58 minutes at rated speed. Run 4.

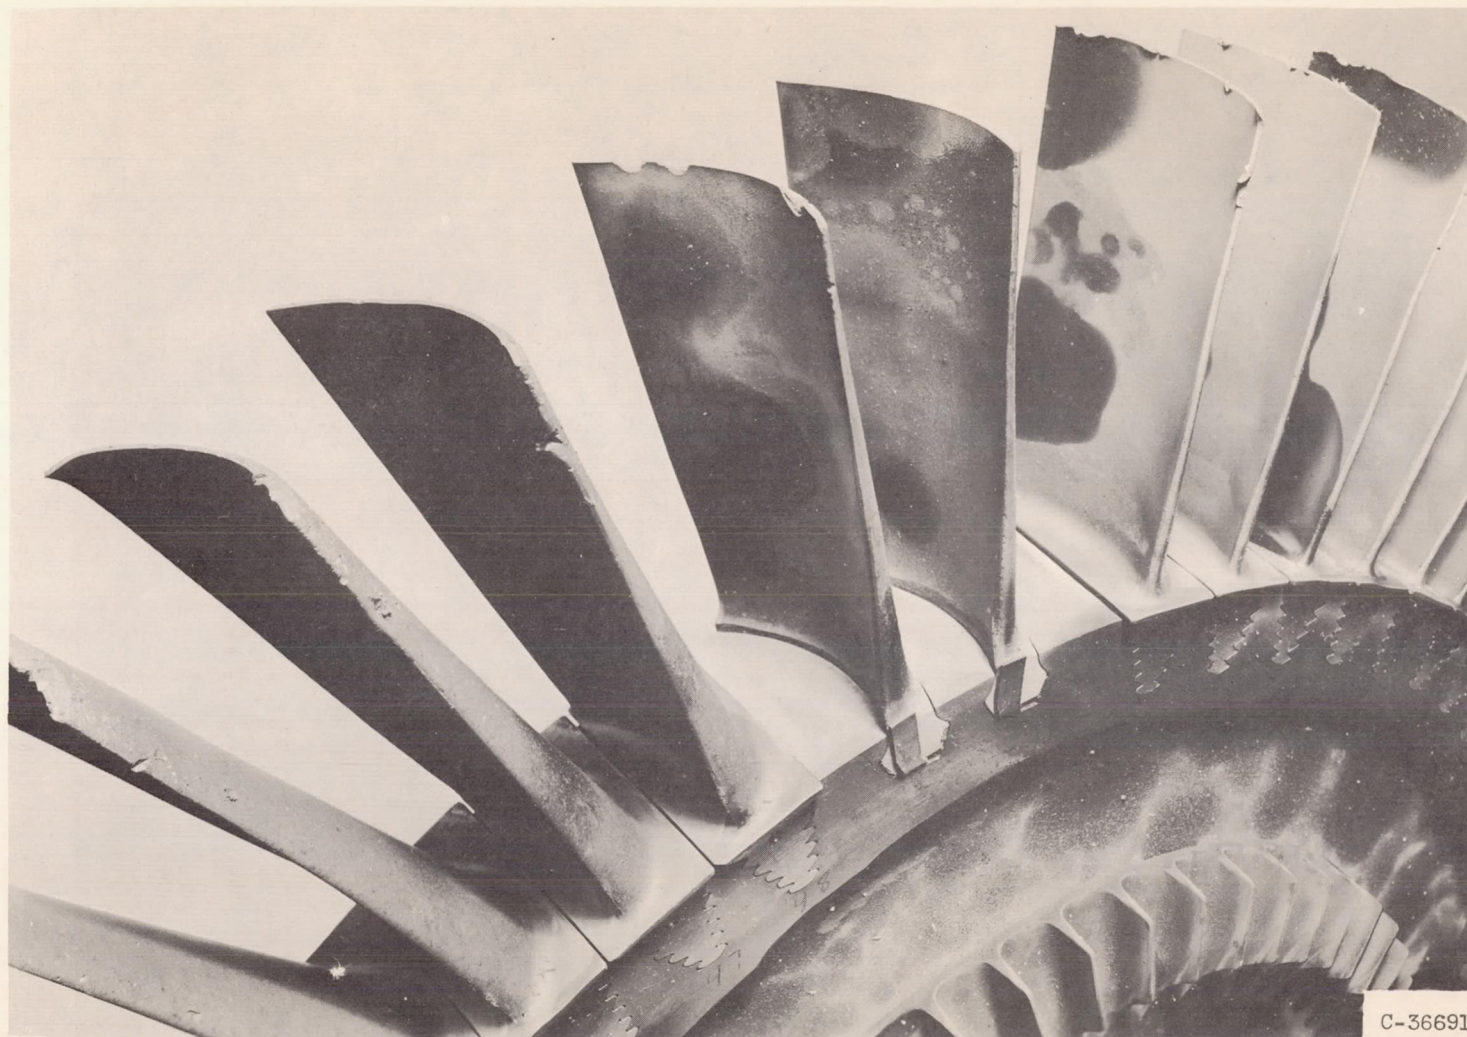
(b) Blades damaged by diametrically opposite blade with root failure.

Figure 8. - Concluded. Failure of curved-root cermet blades after 142 hours and 58 minutes at rated speed. Run 4.

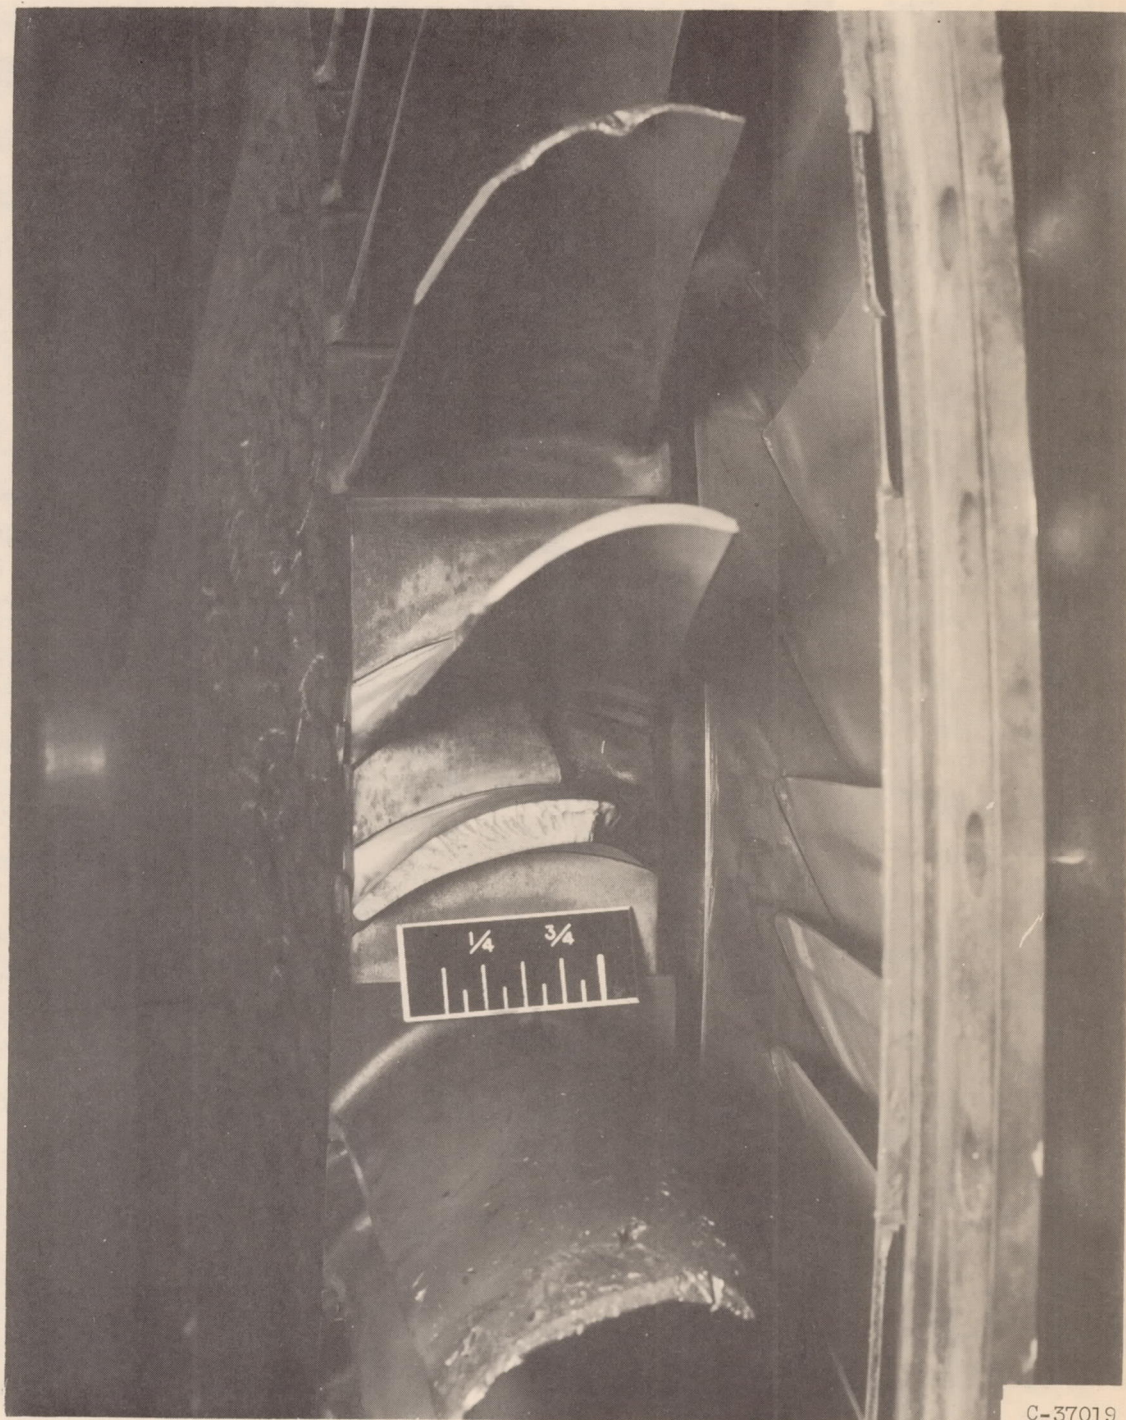
Run 5. - After 102 hours at rated-speed during run 5, the wheel failed in the serration area between two cermet turbine blades (fig. 9), damaging the cermet turbine blades and terminating the run. The wheel had been used for all the runs discussed in this report, accumulating more than 600 hours of rated-speed operation, and had been subjected to 98 starts and stops. As indicated in table I, wheel stress is considerably less with the curved root than with the root forms previously investigated (refs. 3 and 4). The expected stress-rupture life of the rotor alloy had not been attained at the time of failure, and the appearance of the fractured face is not characteristic of a stress-rupture mechanism. Cause of the failure was not determined.

Figure 9. - Failure of turbine wheel containing curved-root cermet turbine blades after 102 hours at rated speed. Run 5.
